NASA TECHNICAL NOTE

NASA TN D-5207

INVESTIGATION OF SA-501 S-IVB AUXILIARY PROPULSION SYSTEM FLIGHT ANOMALIES

*George C. Marshall Space Flight Center
Marshall, Ala.*

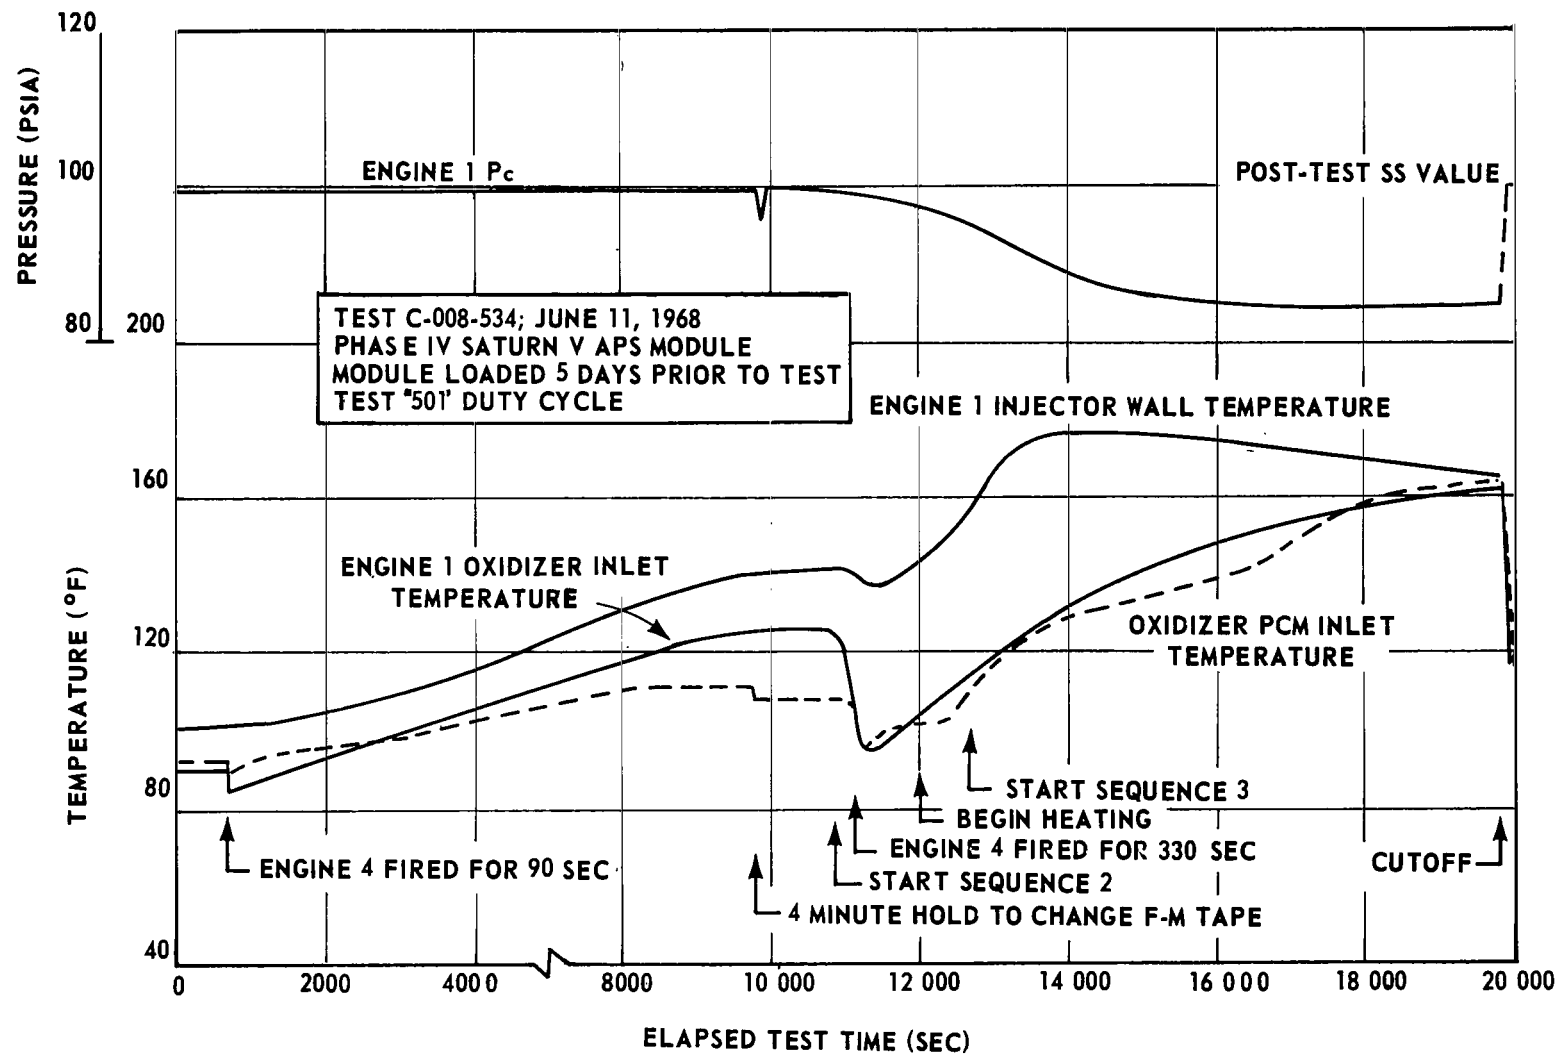
The test data revealed a significant decay in engine Pc with increase in propellant and engine temperature. However, for the initial 12 000 seconds of the tests, there was little variation in the nominal Pc operating levels. The exceptions to this were the times that 3- to 4-minute hold periods were incurred in order to change the F-M recording tape. The initial engine pulses following this hold exhibited reduced Pc values. However, the nominal Pc values were restored after two or three pulses. It was noted that the engine temperatures "soaked out" at higher values during these hold periods. The dense portion of the firing cycle was begun at 10 900 seconds, followed by the beginning of heating of the oxidizer control module at 12 000 seconds. Pc decay began at this point (12 000 seconds) and continued throughout the remainder of the duty cycle. The Pc decay is best illustrated in Figures 10, 11, and 12, which contain curves of engine Pc, engine injector wall temperature, oxidizer inlet temperature, and oxidizer control module (PCM) inlet temperature versus test time for a typical test. The maximum experienced Pc decay in this test program was 32 psia. Note that the Pc values returned to nominal during the post-test steady state firings.

FIGURE 10. ENGINE 1 P_c , INJECTOR TEMPERATURE, AND OXIDIZER SUPPLY TEMPERATURE VERSUS TEST TIME

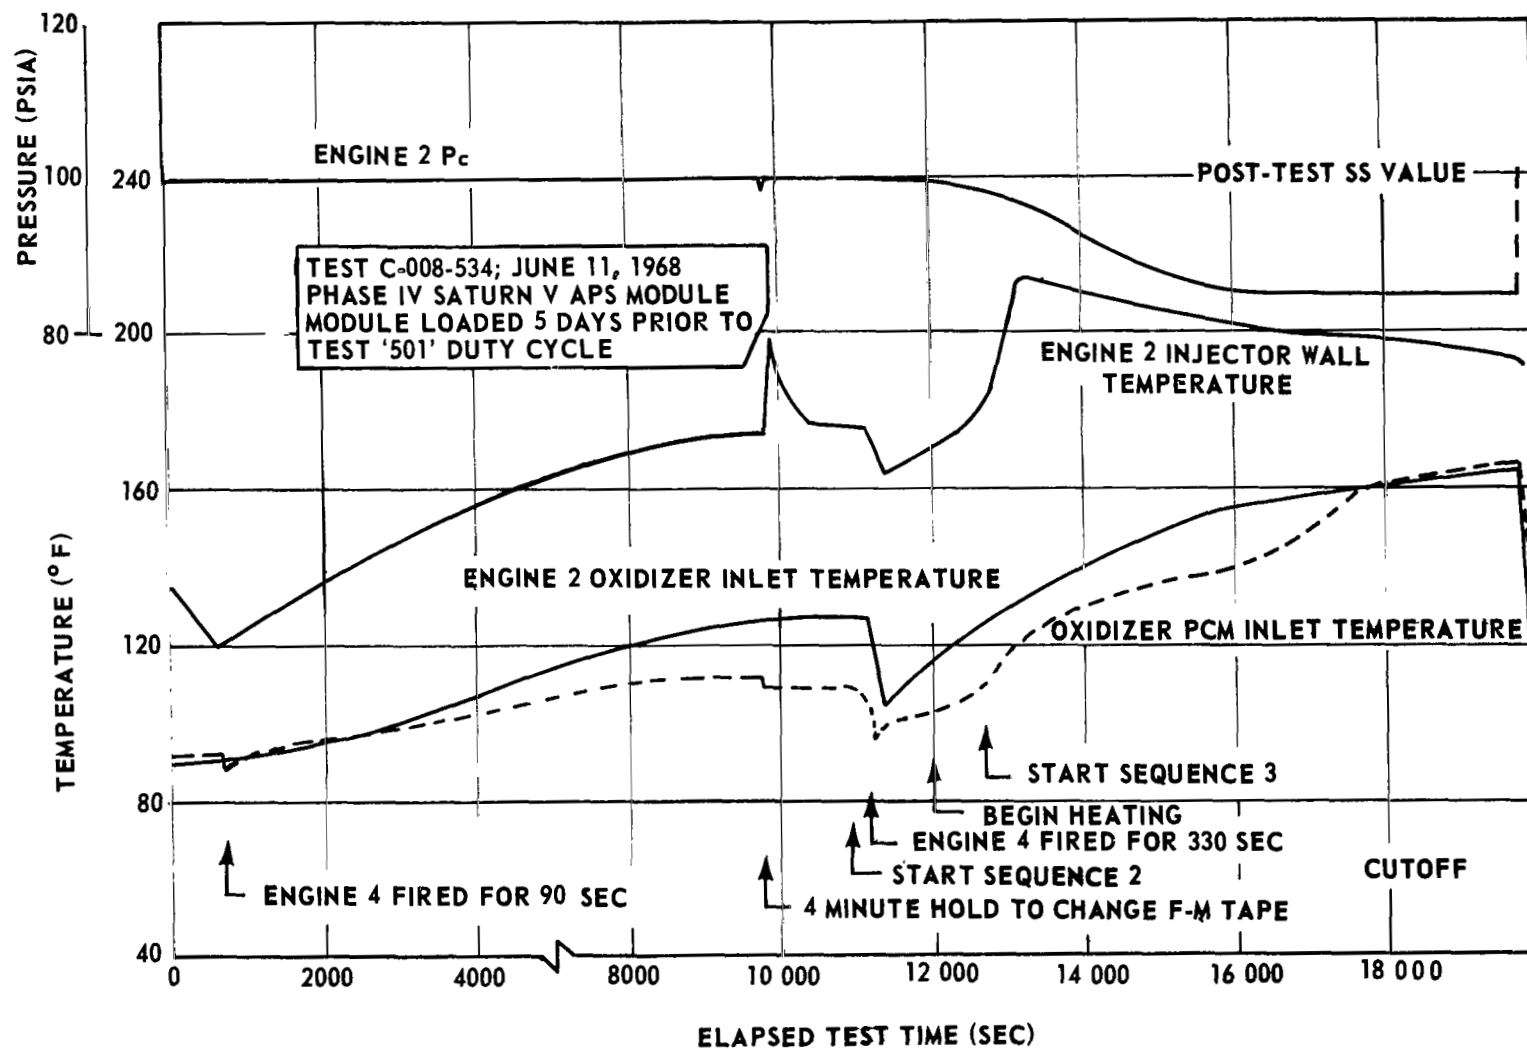
FIGURE 11. ENGINE 2 P_c , INJECTOR TEMPERATURE, AND OXIDIZER SUPPLY TEMPERATURE VERSUS TEST TIME

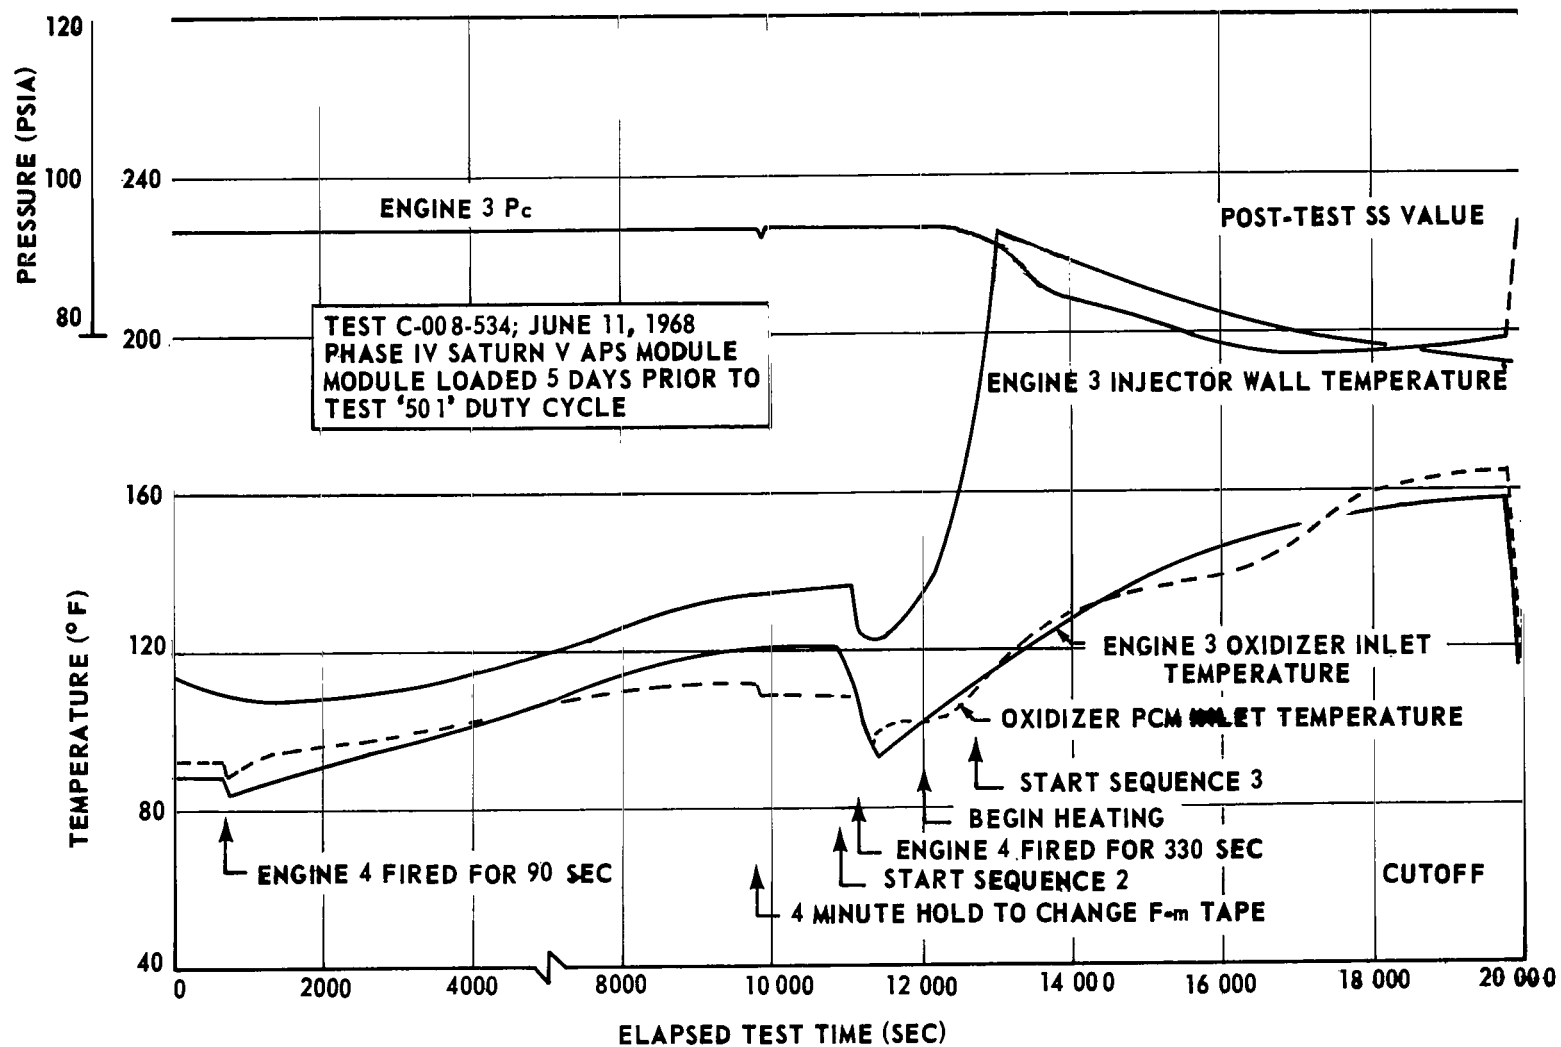
FIGURE 12. ENGINE 3 P_c , INJECTOR TEMPERATURE, AND OXIDIZER SUPPLY TEMPERATURE VERSUS TEST TIME

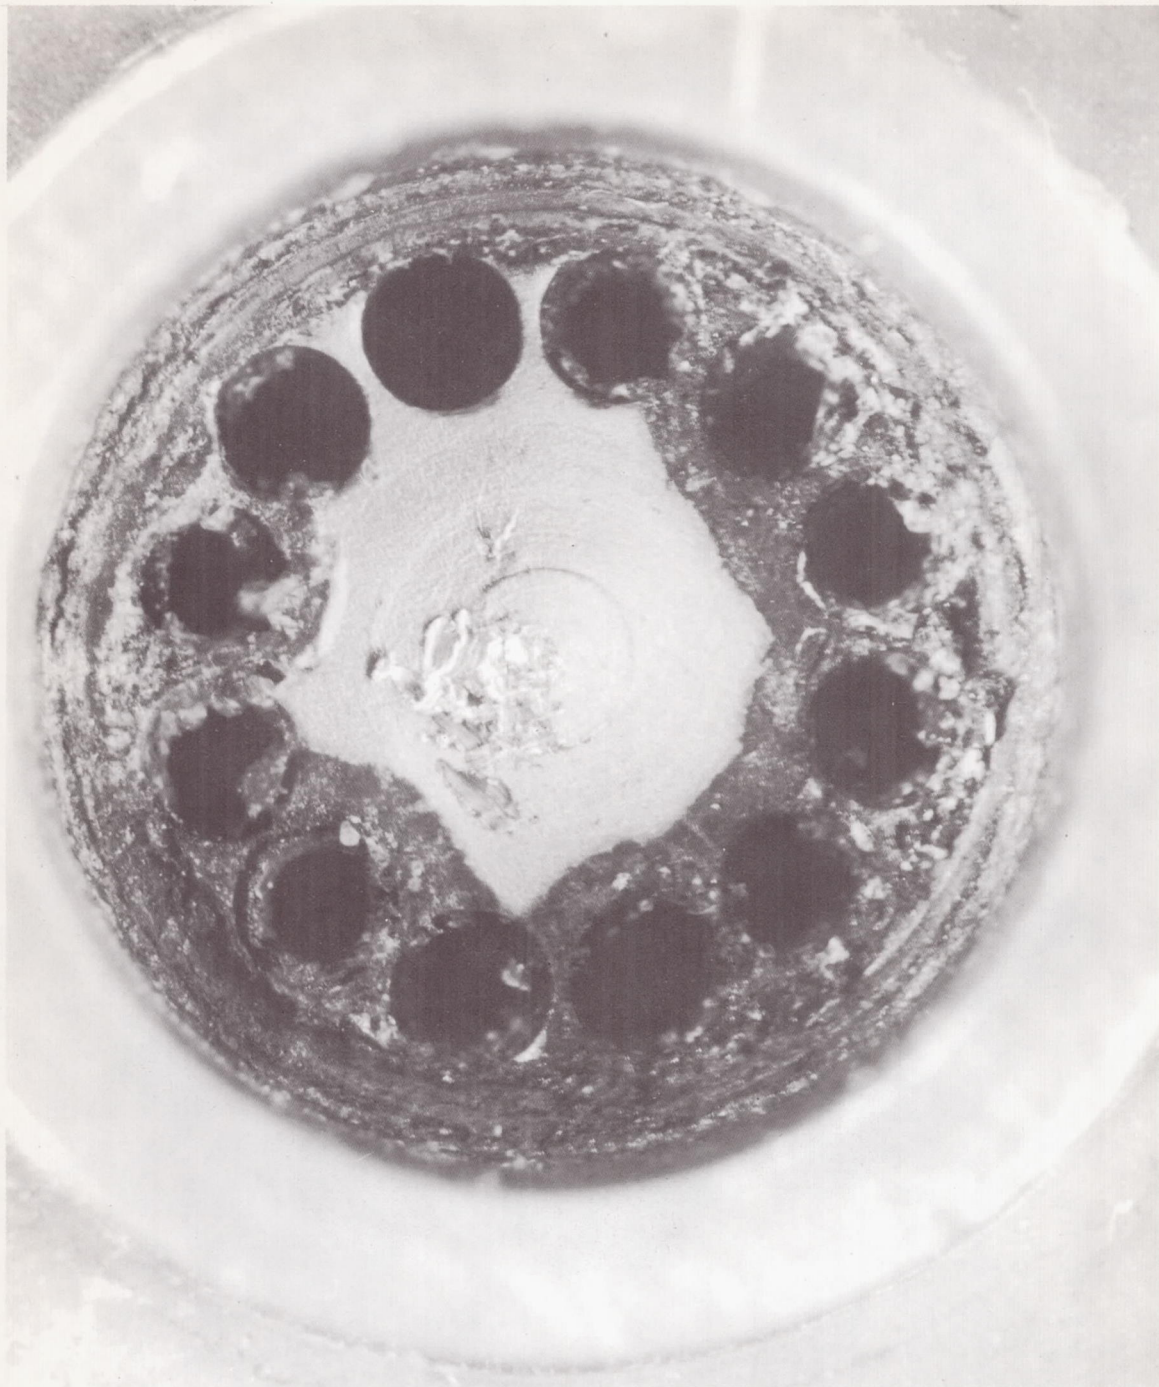
FIGURE 14. CONTAMINATED ENGINE INJECTOR OXIDIZER FLANGE INLET

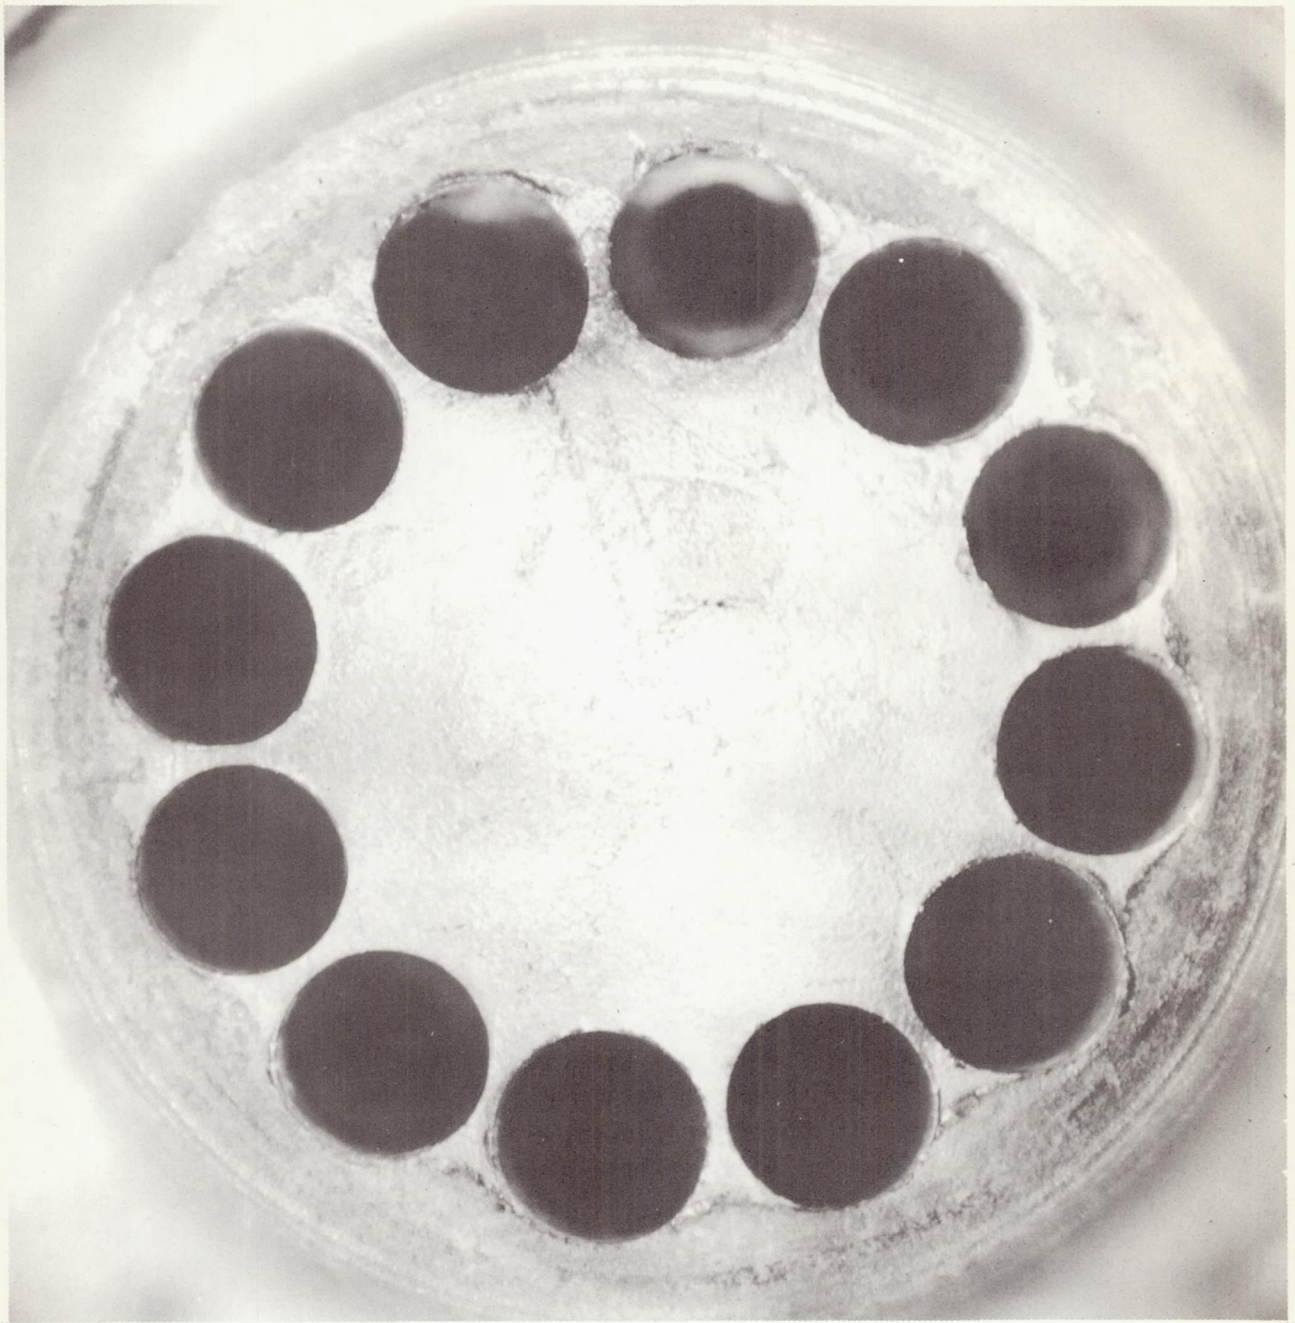
FIGURE 15. CLEANED ENGINE INJECTOR OXIDIZER FLANGE INLET

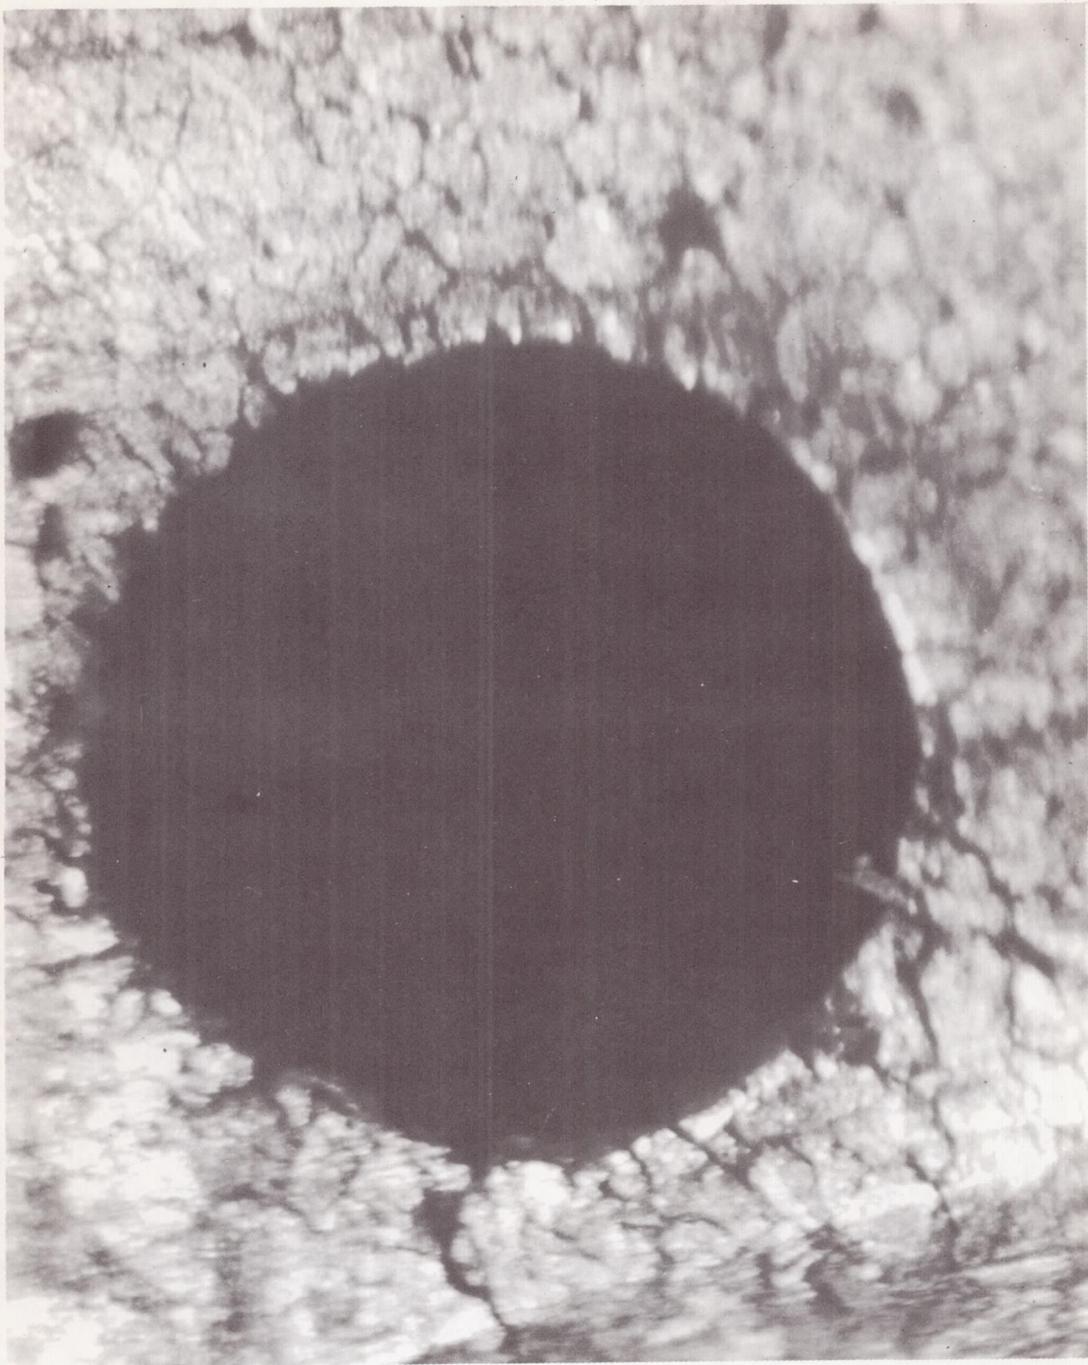
The other phase of the chemical corrosion is the restriction of the flow passages. Since study has indicated that the cause of the problem is in the engines, the only likely area that would experience the conditions of exposure of propellant flow passage hardware to a combination of propellant (N_2O_4) and water is downstream of the engine valves. This would include the cavity at the entrance to the capillary feed tubes and the injector flow passages. The injector and tubes are constructed from Inconel 600 material, which contains a high percentage of nickel (70 percent) and significant percentages of iron and chromium. Nickel and its alloys are generally accepted as being compatible with anhydrous N_2O_4 but are susceptible to attack by nitric acid.

FIGURE 16. CORROSIVE ATTACK ON INJECTOR OXIDIZER
PASSAGE OUTLET
